## Bintry Mill Trout Fishery

Proposed bed raising and bank improvements to the River Wensum above Yarrow Bridge

# Risk assessment and method statement

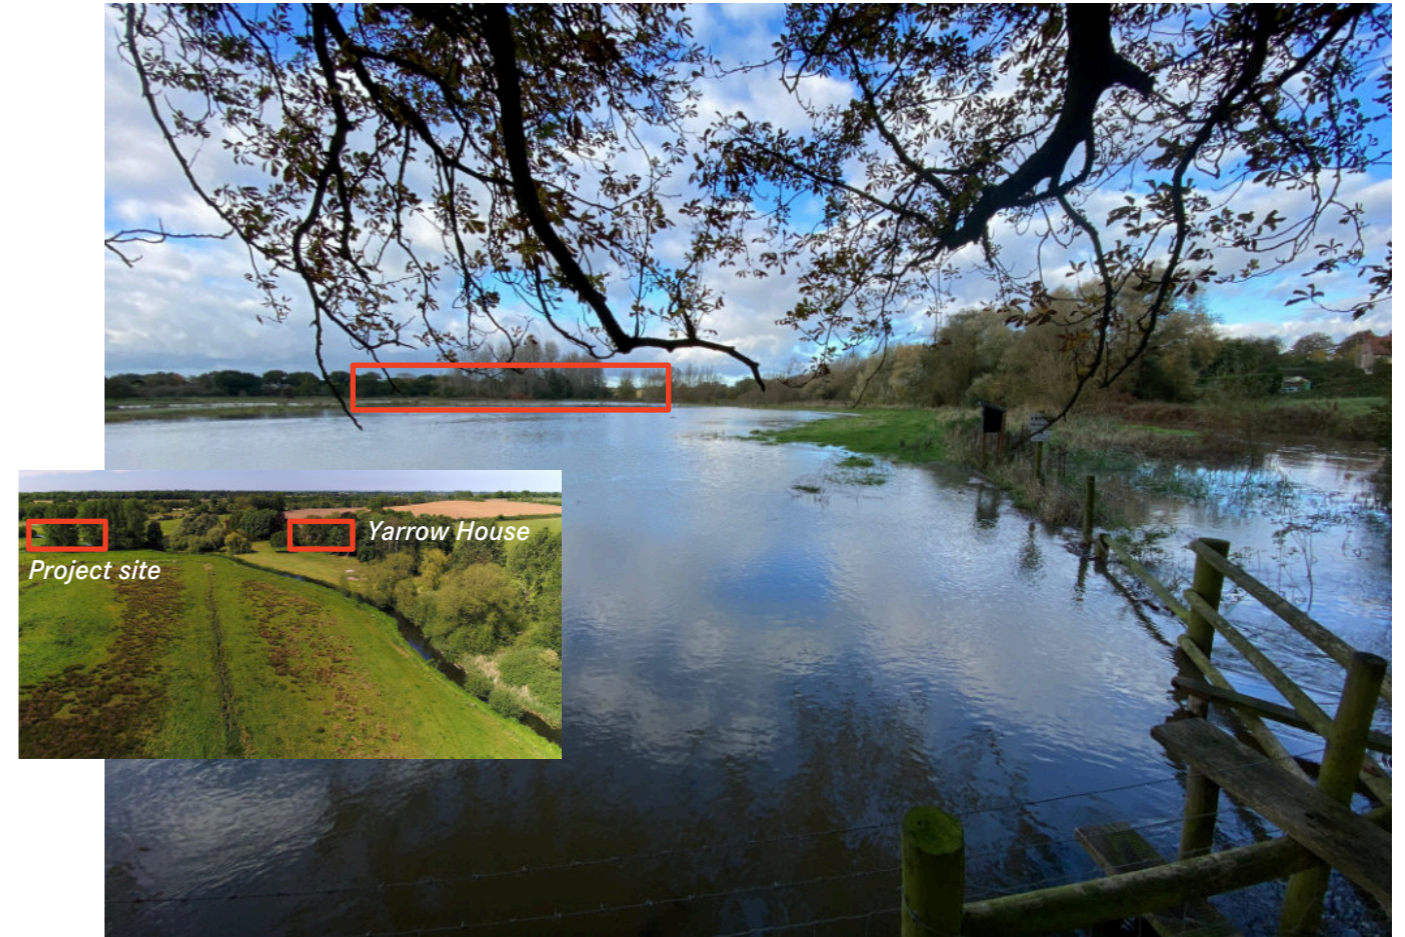
*Above: In this image the main channel is to the right of the picture, with the proposed project site just behind the trees in the distance (marked in red). The water levels, although higher than normal in the very wet winter of 2023/24, are typical of the flood pattern, with the slightly higher dredging spoil immediately adjacent to the river channel and low lying land to the left. The only residence close to the site is Yarrow House (shown on the map, left), but is well above even last winter's excessive flood levels. It certainly would not be affected by this project.*

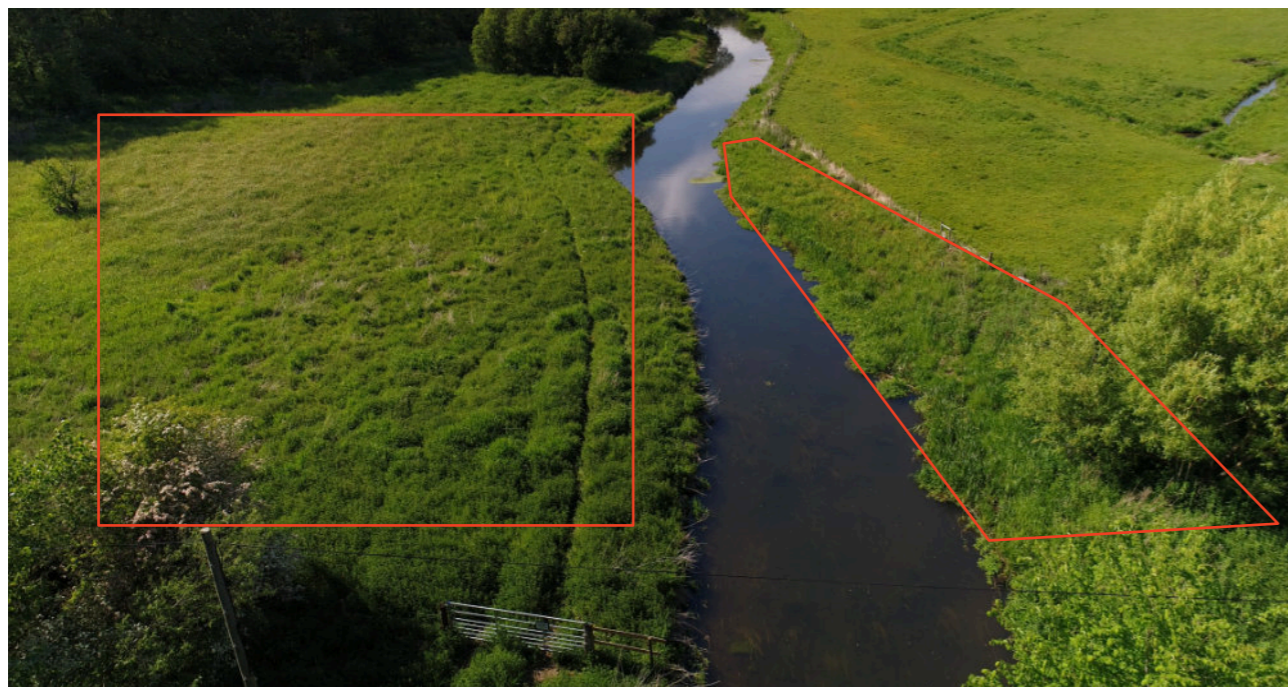
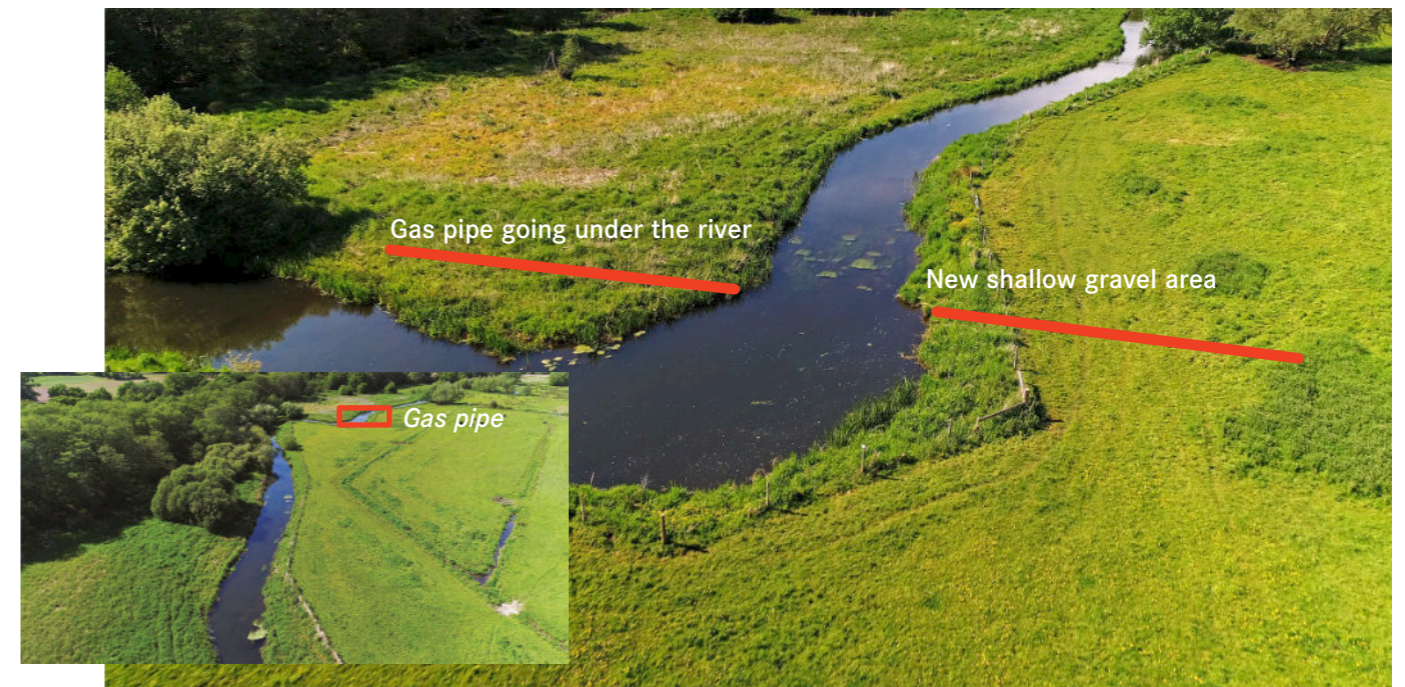
*Below: This bend is approximately 100 metres upstream of the site of the proposed works. Recent work here (summer 2023) involved the laying of a new gas pipe under the river bed. The contractors raised the bed with gravel as part of the process, and even over such a short distance (marked in red) it can be seen that the increased flow has resulted in beneficial weed growth and is a known fish holding spot. We are proposing a similar exercise, but over a distance of 50 - 70 metres. From this photo one can also see that the low lying True Right Hand Bank (TRHB) is a natural spill over area which will readily absorb excess water.*

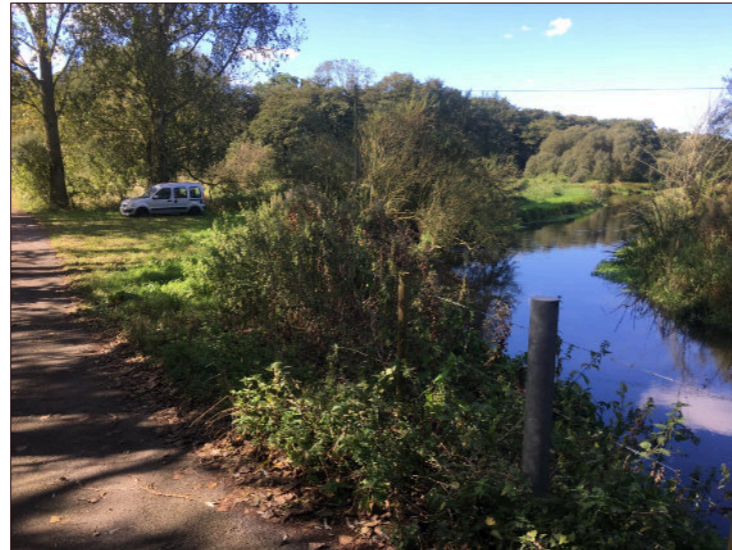
*Below:* The materials will be deposited in regularly spaced heaps by the tracked dumper along the bank as shown (red circles). A 360 digger will then place the large stone into the channel as far out as possible. The 360 will work between 6 and 10 metres from the edge of the bank, roughly following the existing track left by the grass cutting tractor.

The stone and gravel will be deposited in the car park area shown and transported to a number of spots along the bank as shown below. A tracked tipper with a 9 ton maximum capacity will be used to transport the materials to the final site. This will ensure minimum disturbance to the ground.

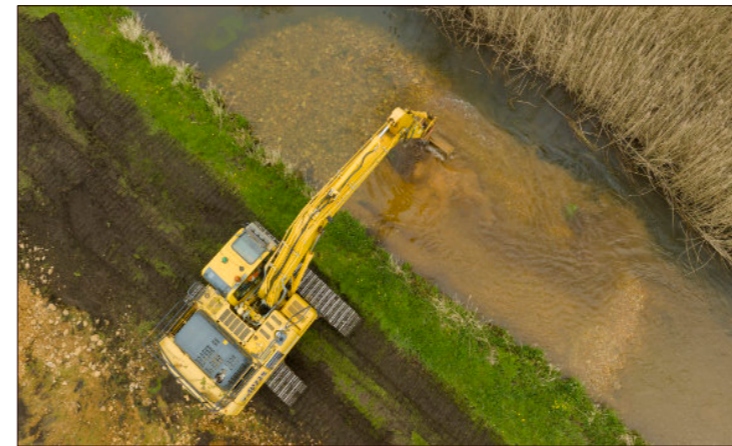
*Top:* The 360 is able to deposit stone and gravel to about ¾ of the way across the channel from pre-delivered piles arranged along the bank. This minimises damage from the digger and speeds up the process.

*Above:* The 360 can arrange the stone to facilitate hand raking afterwards. Using a long reach digger was considered, but rejected due to the excess damage it might cause. Preserving the grazing as much as possible was important to the landowner.

The 360 will probably not be able to get as close to the water's edge as in the photos shown here, due to the reed growth at Yarrow, but experience has shown that with careful supervision the digger can distribute the gravel sufficiently to allow the rest to be raked out by hand. This is time consuming, but does enable us to shape the gravel glide with greater precision.

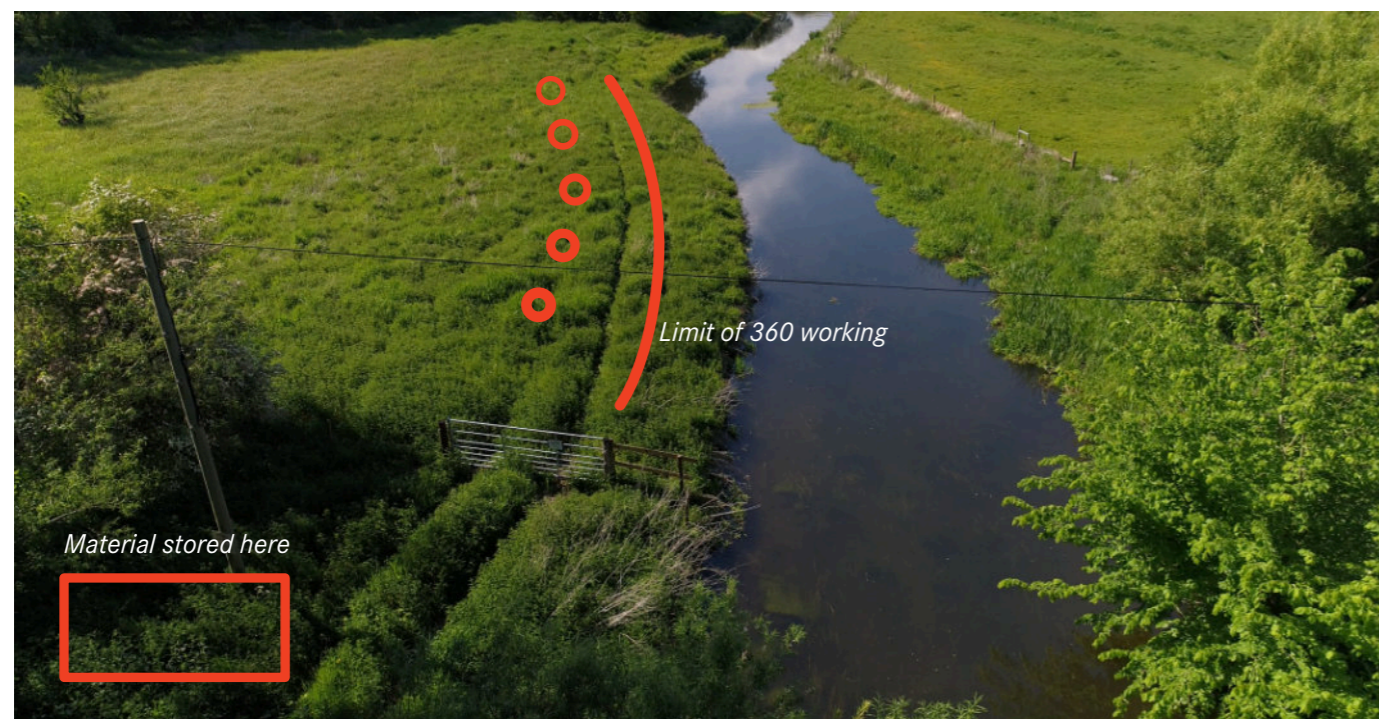
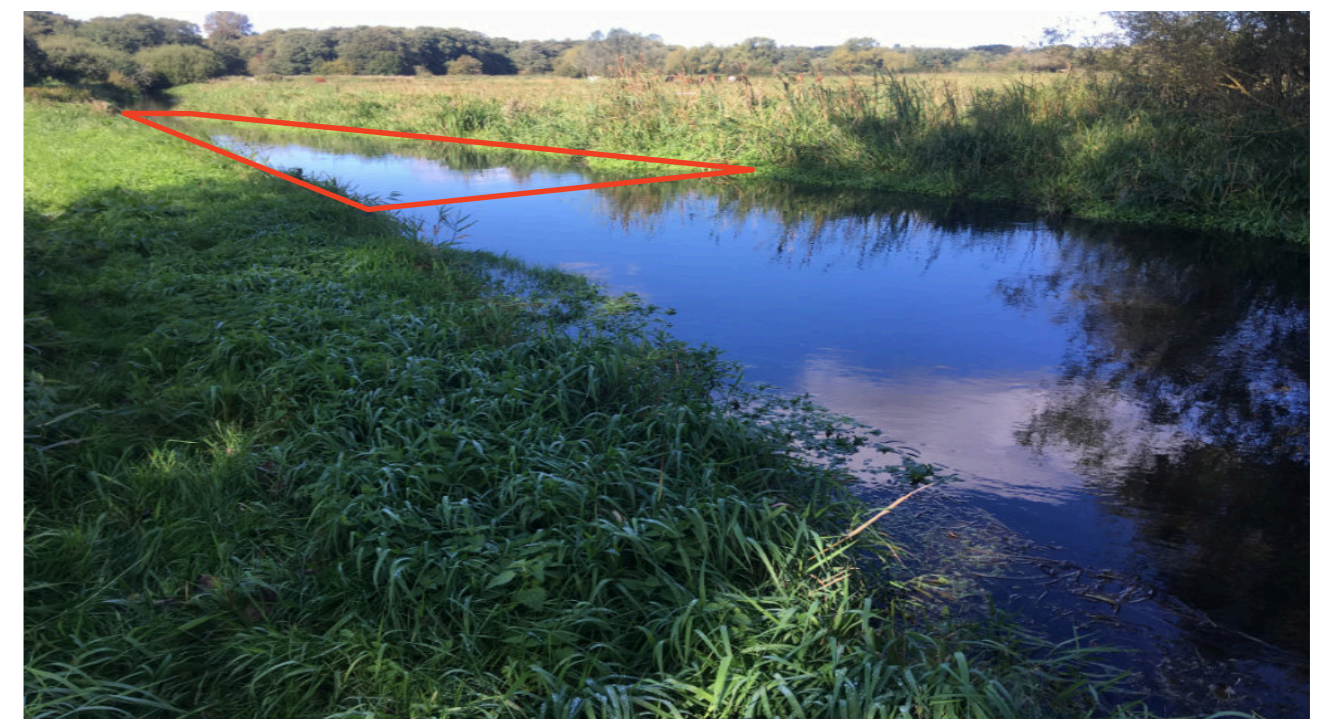
*Below:* The proposed new gravel area at Yarrow is shown here. Experience at County School has shown that the effects of the increased flow will be felt up to 100 yards downstream, with scouring occurring for some distance below the gravel.

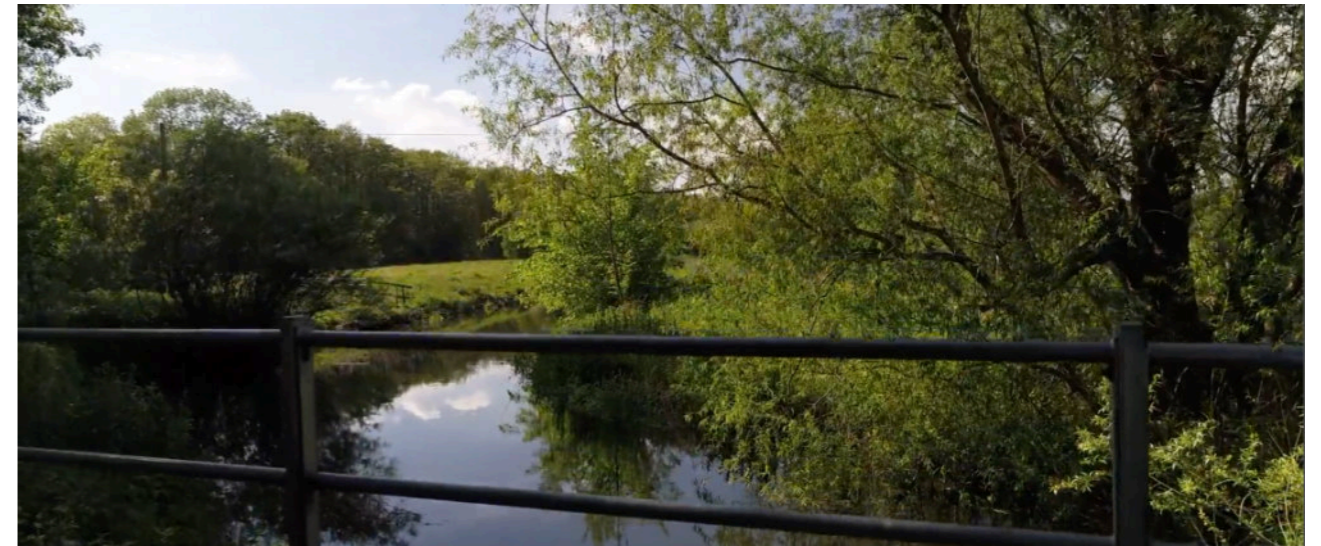
*Right: Previous experience has shown that the effects of the increased flow will be felt for a significant distance downstream. In this instance, the beneficial effects should achieve scouring as far as the bridge. This will create a whole new stretch of improved flow, connecting the new gravel to the previous restoration areas immediately below the bridge.*

*Below: Softer silt near the banks may require more stone than the middle of the channel to counteract any propensity for erosion.*

Previous experience has shown that extra stone will be required along the banks to mitigate losses due to the deeper silt and some bank reinforcement may be required to minimise erosion.

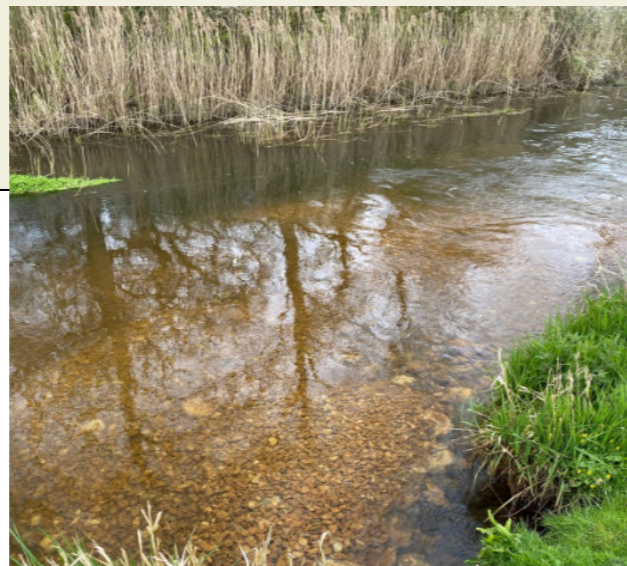
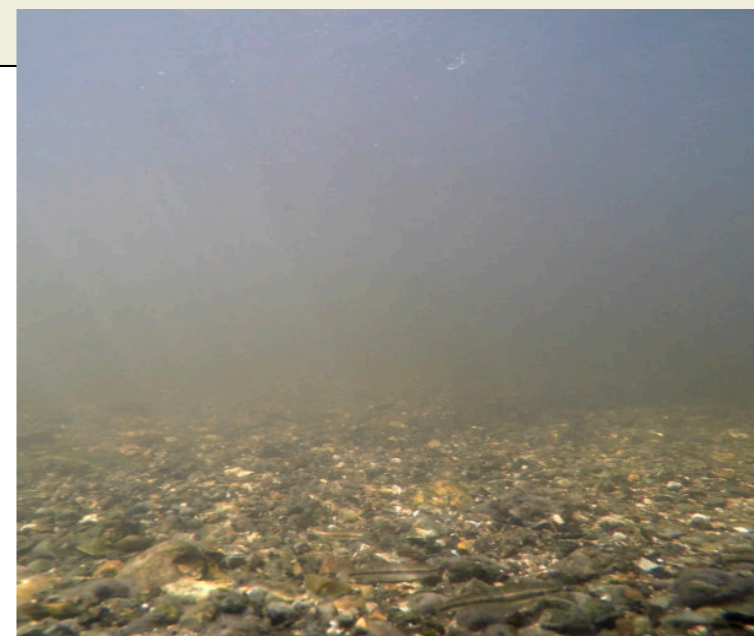
*Left: The final gravel/stone layer will be graded to try and achieve a variety of sizes sufficient to provide suitable spawning gravel for brown trout, chub, dace, perch and roach. Our previous bed raising project at County School has created a permanent home for large numbers of fry of all species, which has in turn attracted predators such as kingfishers, egrets, pike and larger trout and chub which will also feed on the fry.*

*Our experience is that weed growth from the banks will quickly provide new fry sanctuaries, as will woody debris where applicable.*

We propose the use of 2 sizes of stone, larger quarry reject stone ranging from 40mm to 100mm in approximate diameter to smaller gravel which will need to be 10mm to 20mm to facilitate fish spawning activities. There seems little gain in introducing a third category as the size variation within these categories should suffice to be large enough for long term stability on the one hand and small enough to be moved by spawning fish.

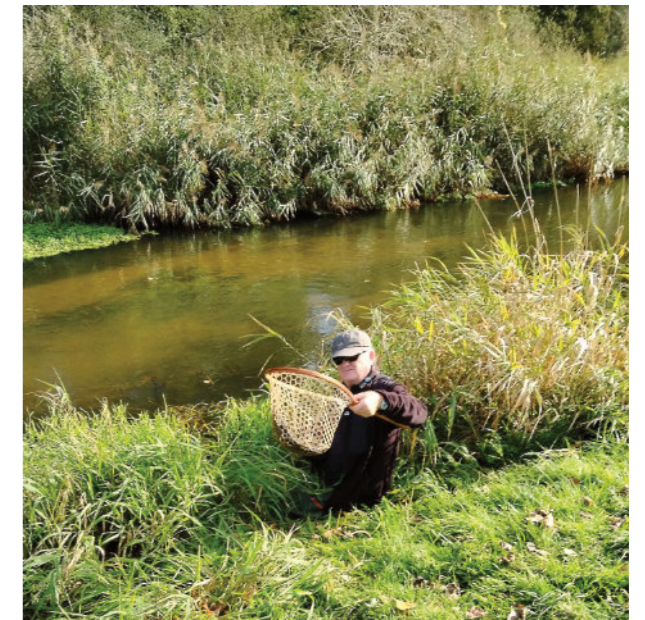
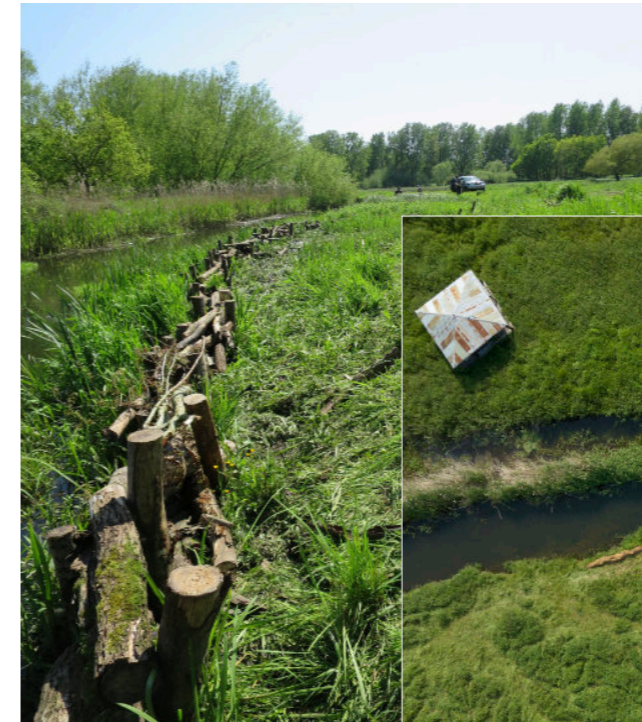
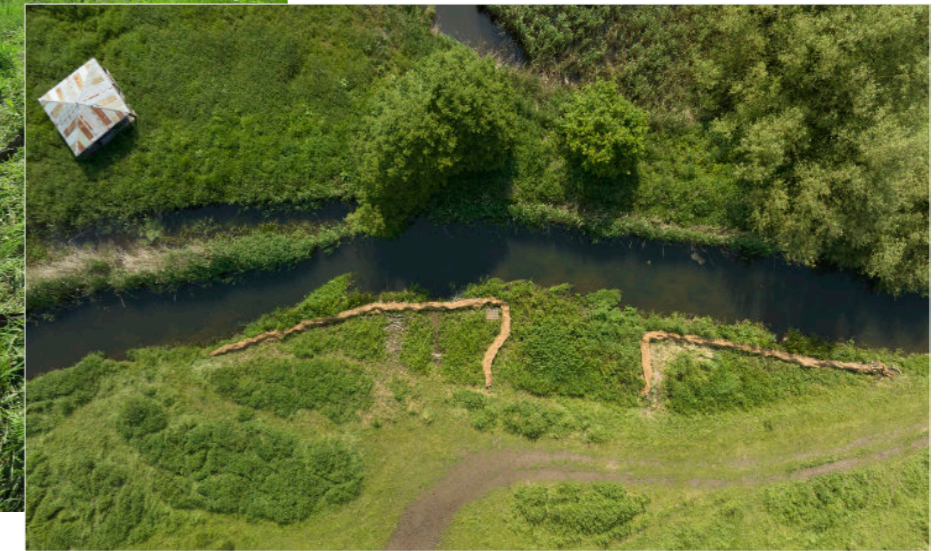
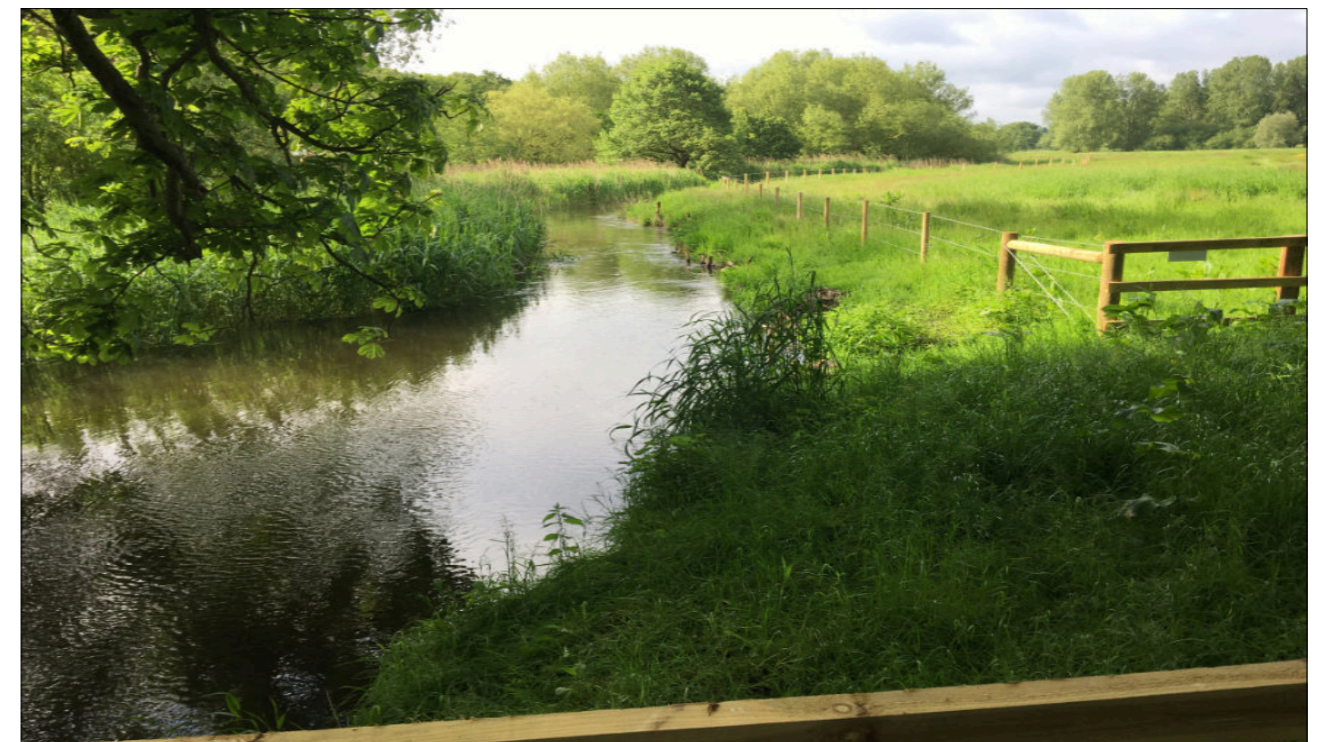
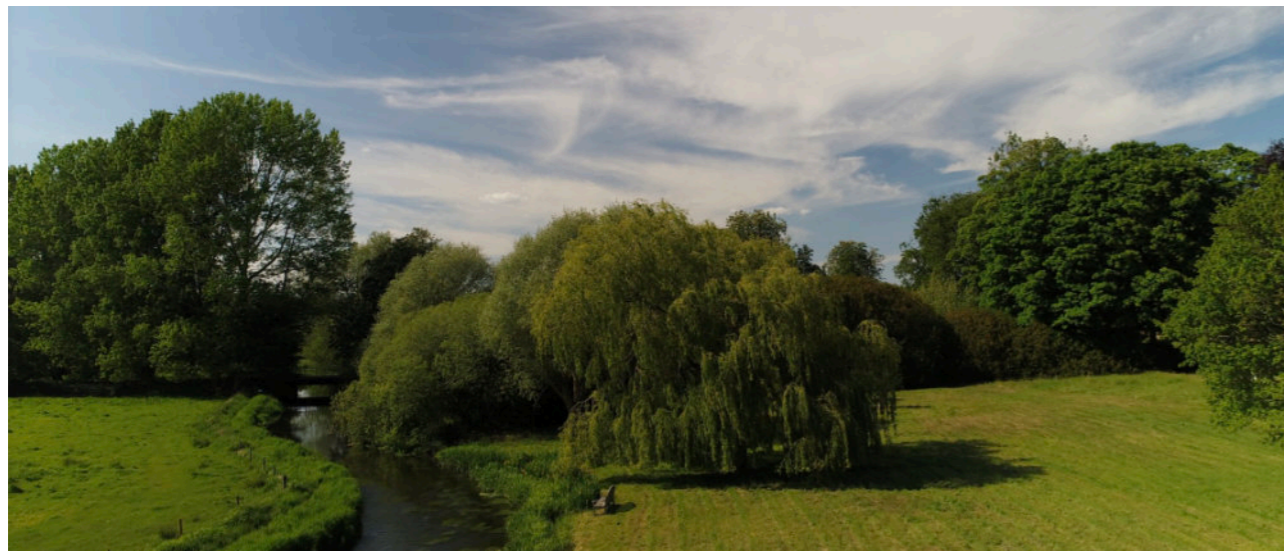
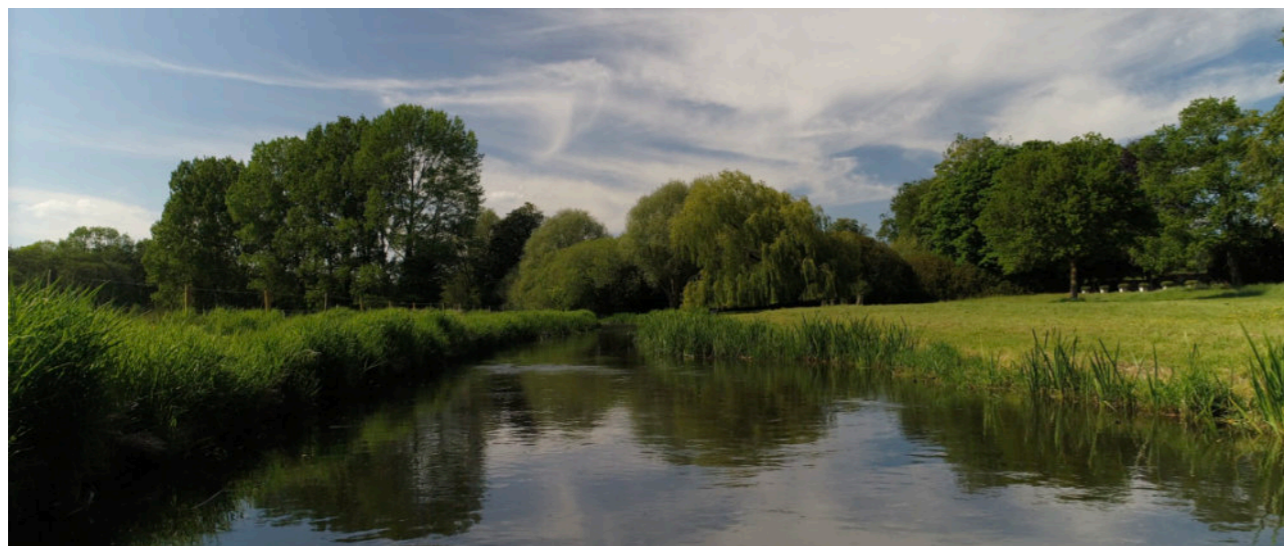
*Below: In the 1990s the Environment Agency restored the stretch of river immediately below Yarrow bridge to form the superb stretch of chalk stream it is today. Our aim is to do whatever is within our means to carry on this work. The projects at County School and above the bridge, although much less ambitious, will nevertheless significantly improve the habitat value of these stretches of water.*

*Right: The new gravel glide at County School has totally transformed that stretch of river.*

*Below: In 2023 club members reinforced the low lying bank and lowered a section of the dredging spoil bank to re-connect the river with its floodplain. Years of poaching by grazing cattle had damaged the bank, which had to be fenced and re-built in some areas.*

*Bottom: The river as it is now, just one season later. The next step is to plant some trees inside the fence for shade and bank stability.*
